## RELATIONSHIP BETWEEN SITE INFRASTRUCTURE AND THE EFFECTIVENESS OF ENVIRONMENTAL FIRE PROTECTION SYSTEMS IN SEI RENGAS PERMATA SUBDISTRICT, MEDAN CITY, INDONESIA

Dara Amalia<sup>1</sup>, Amy Marisa<sup>1</sup> and N. Vinky Rahman<sup>1</sup>

<sup>1</sup>Universitas Sumatera Utara, Faculty of Engineering, Master of Architecture Program, Jl. Perpustakaan, Padang Bulan, Medan Baru, Medan 20155, North Sumatra, Indonesia daraamalia281@gmail.com

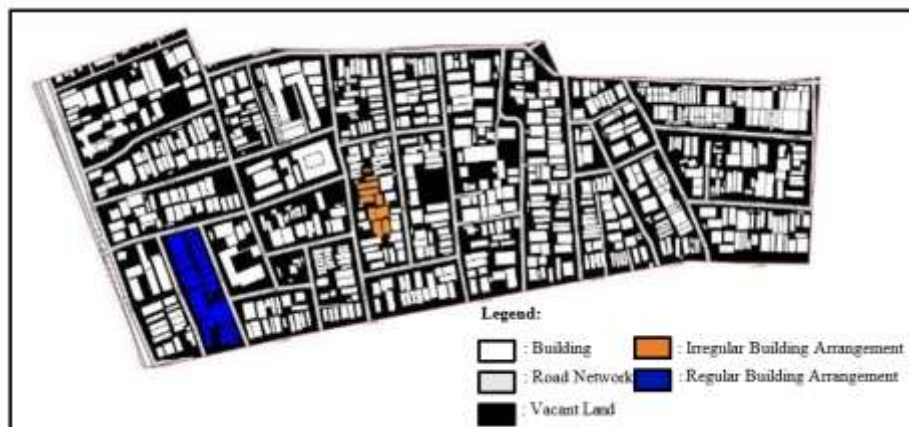
**Figure 2: Building Arrangement Pattern Between Buildings**

Based on the field observations, most buildings in Sei Rengas Permata Subdistrict are attached to one another with little or no separation within individual residential blocks, resulting in relatively low building spacing at the micro scale. Nevertheless, the settlement is organized into a grid-like block pattern separated by neighborhood access roads, providing physical separation between adjacent blocks. This indicates that the spatial separation of buildings in the study area is influenced more by the presence of the road network than by the spacing between individual buildings within each residential block (Figure 2).

On the other hand, the overall building layout generally follows the neighborhood road network, creating a relatively orderly settlement pattern. Most buildings are aligned parallel to the roads and form clearly defined residential blocks. Although several buildings exhibit non-uniform orientations due to the area's gradual and incremental development, the overall building layout in Sei Rengas Permata Subdistrict can be considered well organized, as it remains largely structured around the road network, which serves as the primary organizing element of the settlement (Figure 2).

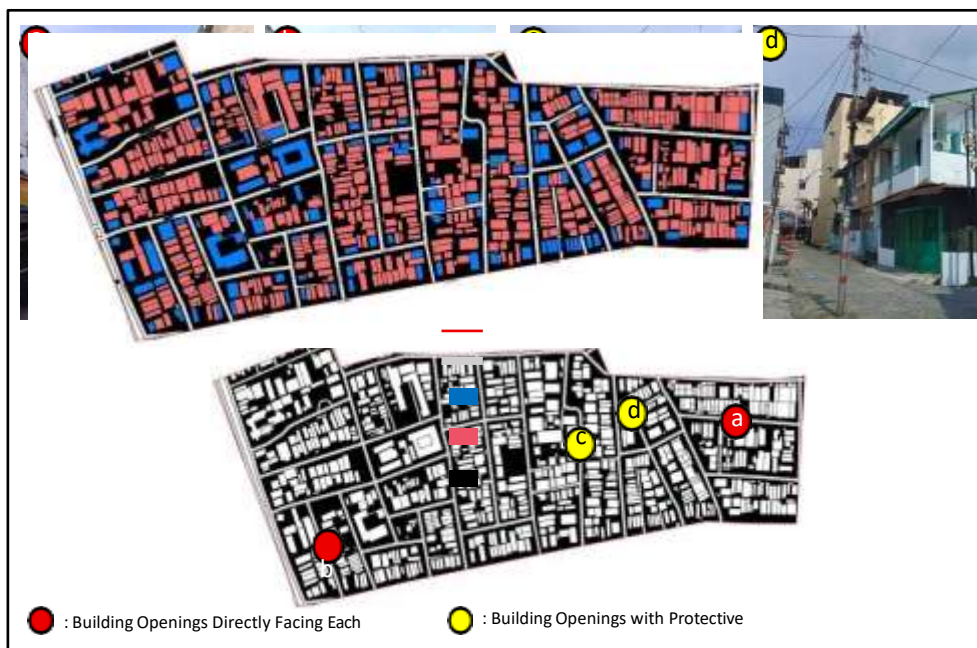
**Figure 3: Building Opening Orientation**

Furthermore, the building openings are generally oriented toward the neighborhood roads or alleys, which serve as the primary access routes to the buildings. This is reflected in the predominance of doors and windows facing the circulation network, indicating that residents' daily activities are concentrated along the neighborhood access roads. In addition, the spacing between building openings is generally adequate, and most openings do not directly face one another. Overall, the orientation of building openings in Sei Rengas Permata Subdistrict follows the neighborhood road network, while variations in the configuration of openings are influenced by the building layout characteristics of each residential block (Figure 3).

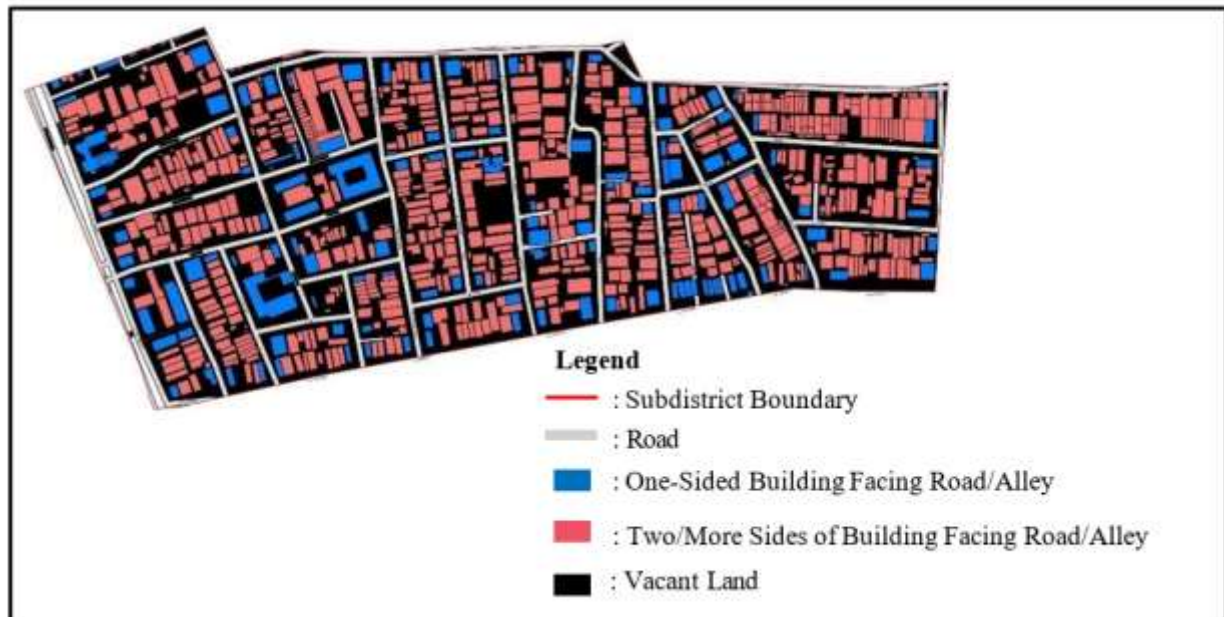
**Figure 4: Building Orientation Toward Roads**

Meanwhile, the arrangement of buildings in relation to the road network generally shows that one side of the building directly faces the neighborhood road or alley, while the other sides are adjacent to surrounding buildings. This condition creates rows of buildings that extend along the road network, resulting in a more structured settlement pattern. In several locations, buildings were also found at road intersections or with more than one side directly facing the road; however, such cases were relatively limited. Overall, the relationship between building arrangement and the road network indicates that roads serve as the primary elements shaping the settlement structure in Sei Rengas Permata Subdistrict (Figure 4).

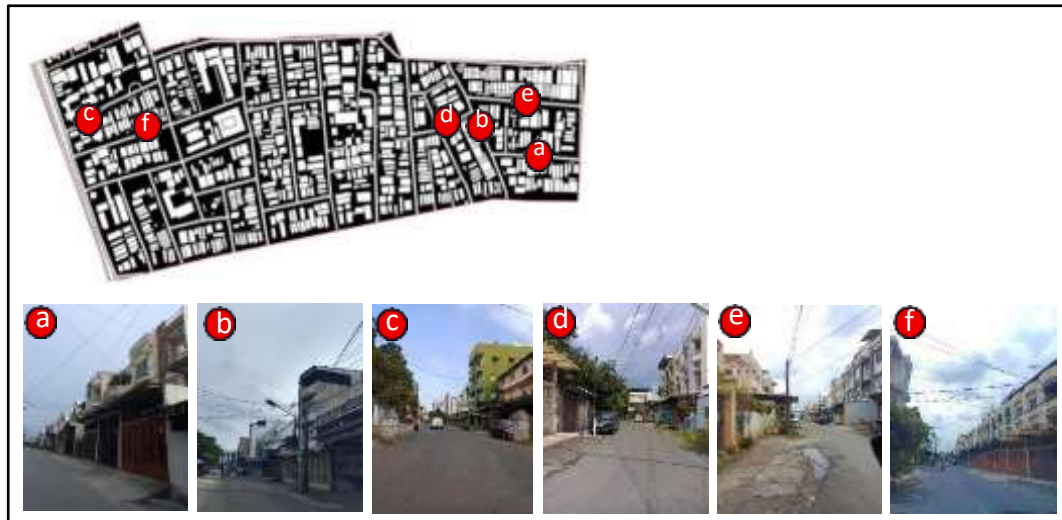
**Figure 5: Building Spacing Width**

The building spacing in Sei Rengas Permata Subdistrict remains varied. In most residential blocks, buildings are positioned relatively close to one another, resulting in limited spaces between adjacent buildings. This condition is particularly evident in rows of houses that have developed linearly within residential blocks. Meanwhile, several locations still have buildings with wider separation distances, particularly along areas adjacent to neighborhood access roads or open spaces. Overall, the building spacing in Sei Rengas Permata Subdistrict is not evenly distributed and remains dominated by buildings with relatively narrow separation distances within residential blocks (Figure 5).

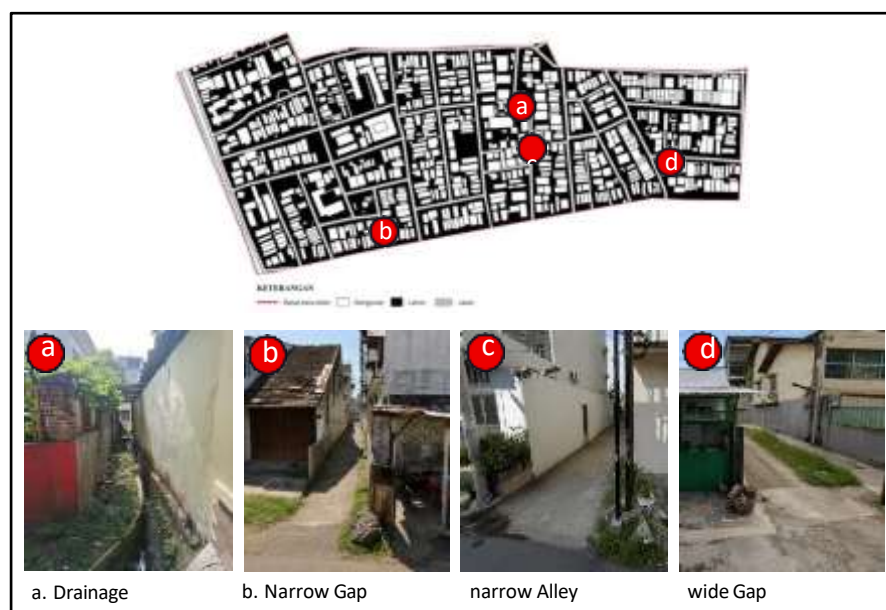
**Figure 6: Separation Elements (a) Drainage; (b) Narrow Gap; (c) Narrow Alloy; (d) Wide Gap**

Furthermore, the building separation elements in Sei Rengas Permata Subdistrict consist of neighborhood access roads, drainage systems, pathways between buildings, and open gaps distributed across several parts of the area. The presence of these elements indicates physical separation between building blocks and groups of buildings, although their distribution is not evenly spread throughout the settlement. In some locations, separation elements are clearly visible, while in other areas buildings have developed with limited or no significant physical separation. Overall, the separation elements found in Sei Rengas Permata Subdistrict demonstrate variations in form and function; however, they have not yet become dominant features that shape the overall structure of the residential area (Figure 6).

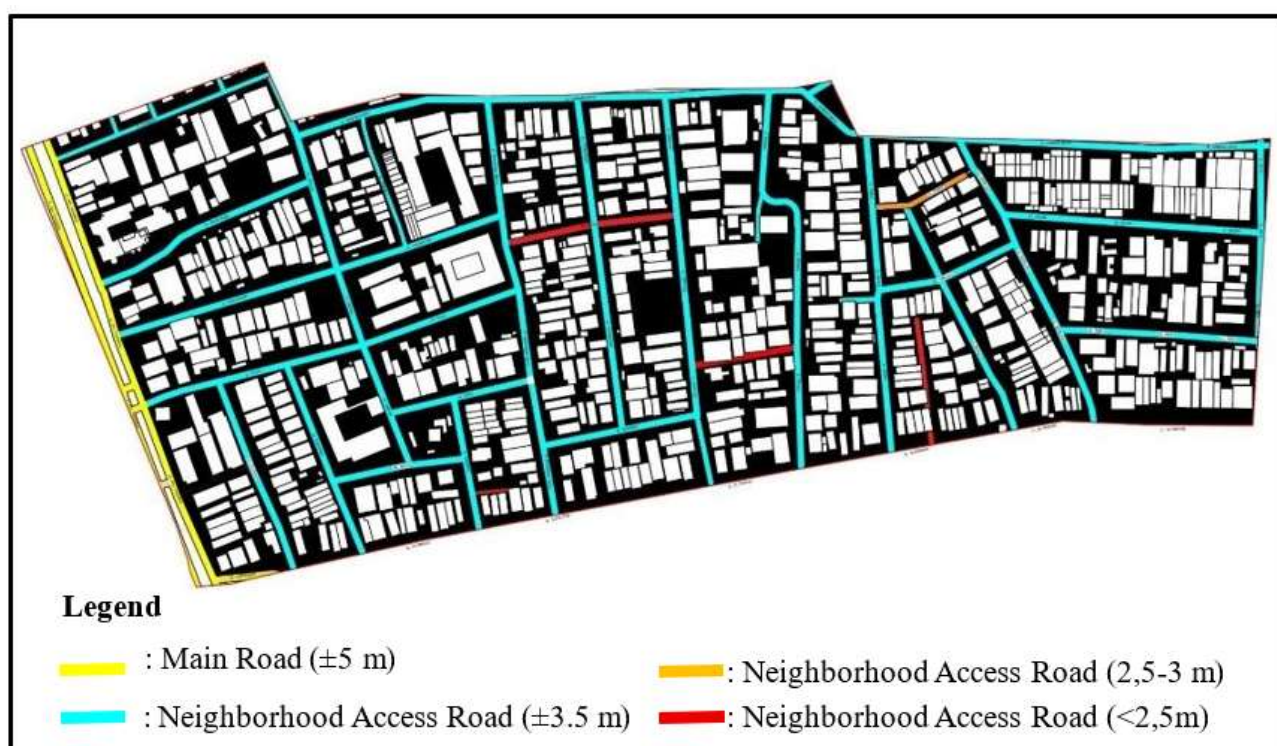
**Figure 7: Road Width**

The neighborhood access roads in Sei Rengas Permata Subdistrict are predominantly characterized by road widths ranging from approximately 3.5–6 meters. These widths are generally found on the main

neighborhood roads connecting residential blocks, while several inner-area roads have more limited dimensions. Visually, the road network provides relatively good connectivity between different parts of the settlement and reaches most residential blocks. This condition indicates that the width of neighborhood access roads in Sei Rengas Permata Subdistrict varies across the area; however, it is still predominantly composed of roads with wider dimensions compared to typical neighborhood access roads (Figure 7).

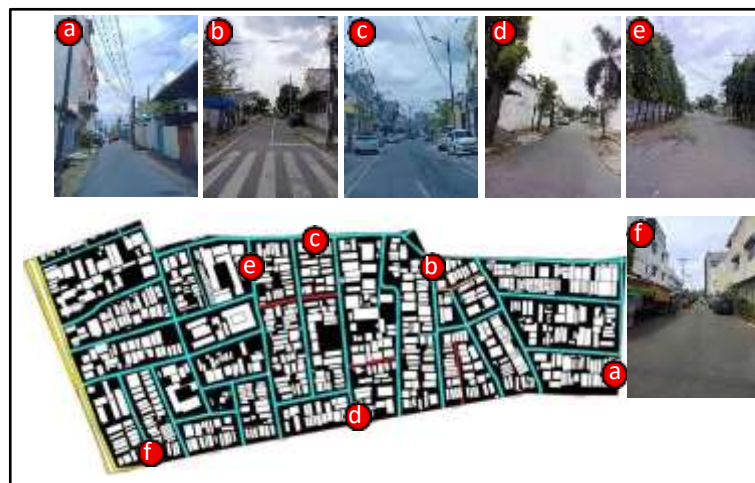
**Figure 8: Road Surface Condition**

In addition to road width, road surface condition is another important aspect that needs to be considered. The neighborhood access roads in Sei Rengas Permata Subdistrict are predominantly paved with asphalt and are generally in good condition. Most road sections have relatively flat and even surfaces, with no significant damage identified, such as potholes or surface deterioration. This condition is observed across the main neighborhood roads as well as several internal roads within the residential area. Overall, the road surface condition in Sei Rengas Permata Subdistrict demonstrates good physical quality and is supported by the use of adequate pavement materials (Figure 8).

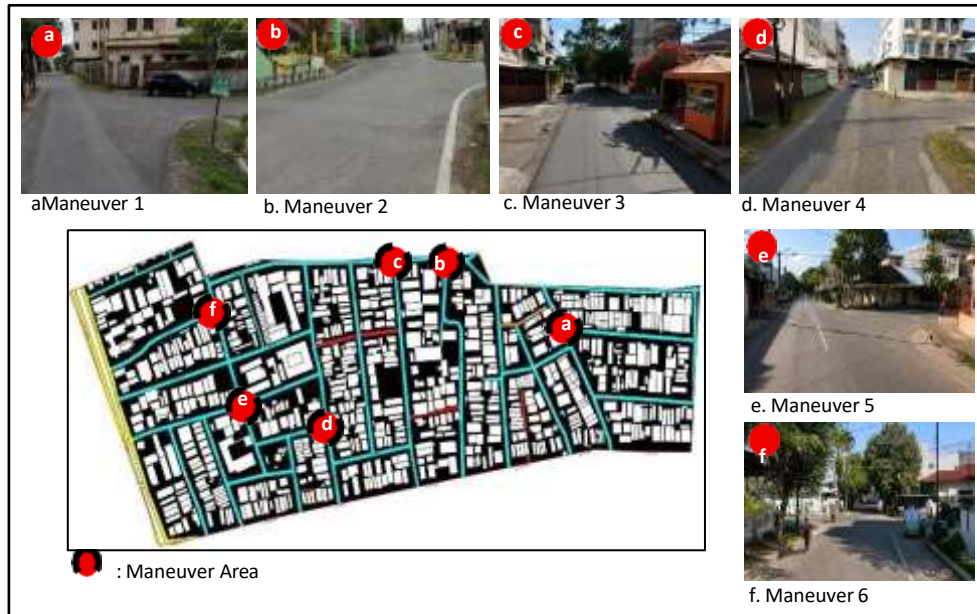
**Figure 9: Maneuver Area**

Furthermore, the road network maneuverability in Sei Rengas Permata Subdistrict generally forms circulation routes that surround most residential blocks. This condition is reflected in the connectivity between road sections, which allows vehicle movement from more than one direction in several parts of the area. Nevertheless, some residential blocks are still located along dead-end roads or have limited circulation routes, resulting in uneven maneuverability throughout the settlement. Overall, the road network in Sei Rengas Permata Subdistrict has established a relatively clear circulation pattern and is capable of connecting most parts of the residential area (Figure 9).

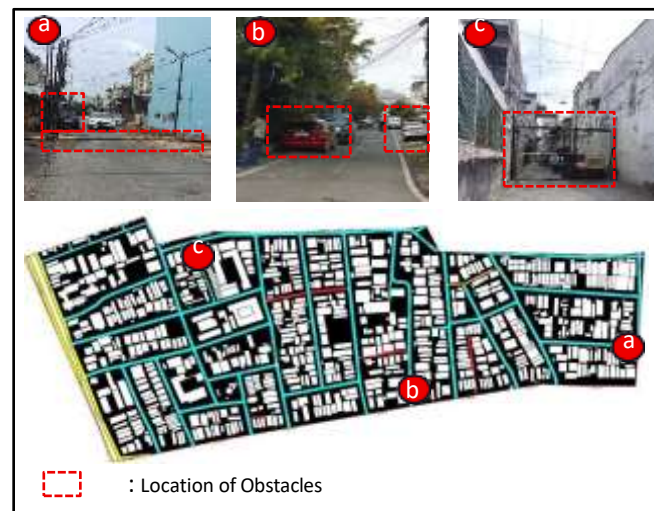
**Figure 10: Road Obstacles**

Meanwhile, regarding road obstructions, several road sections in Sei Rengas Permata Subdistrict still experience various obstacles that occupy parts of the road space. These obstructions include vehicles parked along the roadway, utility poles, roadside stalls or activities, and other physical elements that reduce the effective road width at certain points. Although these conditions are not present throughout the entire road network, they remain visible in several parts of the residential area. Overall, the neighborhood access roads in Sei Rengas Permata Subdistrict remain accessible; however, localized obstructions still affect the physical condition and effective capacity of the road space (Figure 10).

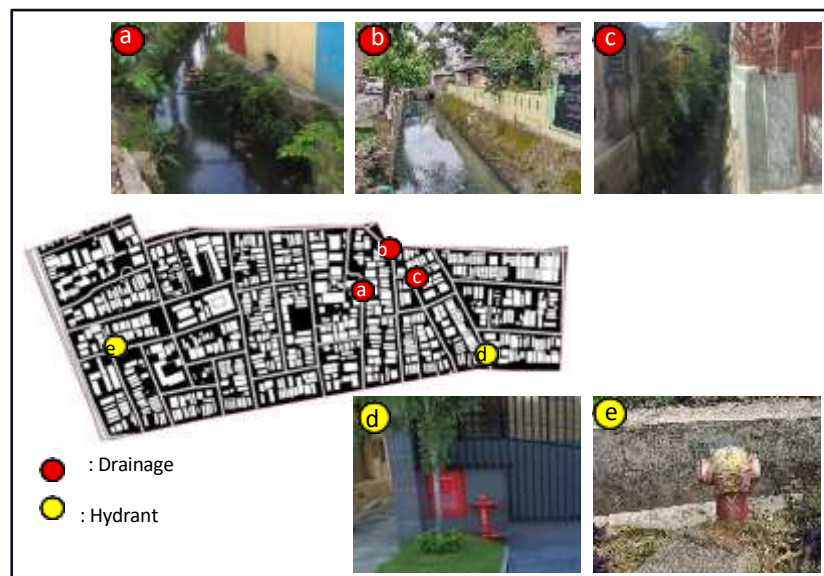
**Figure 11: Water sources**

The observation results indicate that water supply sources in Sei Rengas Permata Subdistrict are predominantly derived from artificial water sources, including the municipal water supply network (PDAM), drainage systems, and hydrants distributed across several locations. Meanwhile, natural water sources such as rivers, lakes, or ponds were not identified within the study area. The distribution of artificial water sources also shows different characteristics, where the PDAM network is available throughout most of the area, while hydrants are only found at specific and limited locations. Overall, this condition indicates that the availability of water supply sources in Sei Rengas Permata Subdistrict relies more heavily on artificial water infrastructure rather than natural water sources (Figure 11).

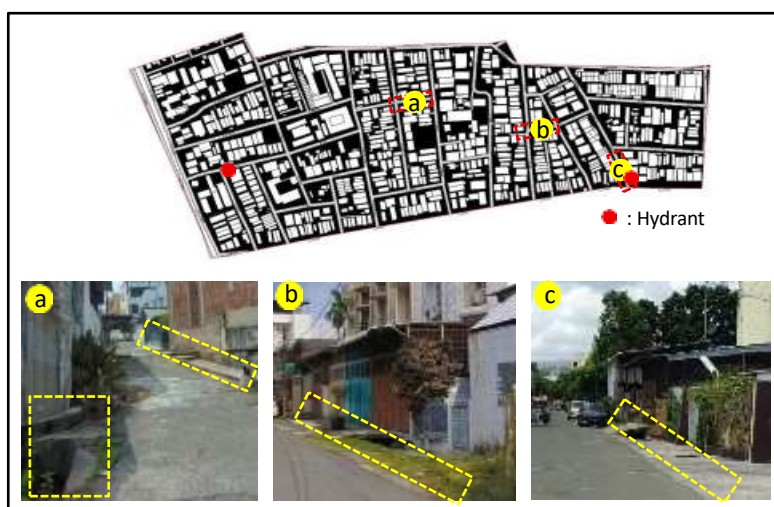
**Figure 12: Drainage segments are covered**

Furthermore, the water source coverage in this subdistrict is not evenly distributed throughout the area. The municipal water supply network (PDAM) is relatively accessible because it follows the distribution pattern of residential areas, whereas hydrants and drainage channels can only be accessed at specific locations. This condition results in varying levels of water source accessibility between different parts of the settlement, particularly in residential blocks located farther from available water supply points. Overall, the coverage of water supply sources in Sei Rengas Permata Subdistrict shows spatial variation, indicating that not all areas have the same level of accessibility to available water sources (Figure 12).

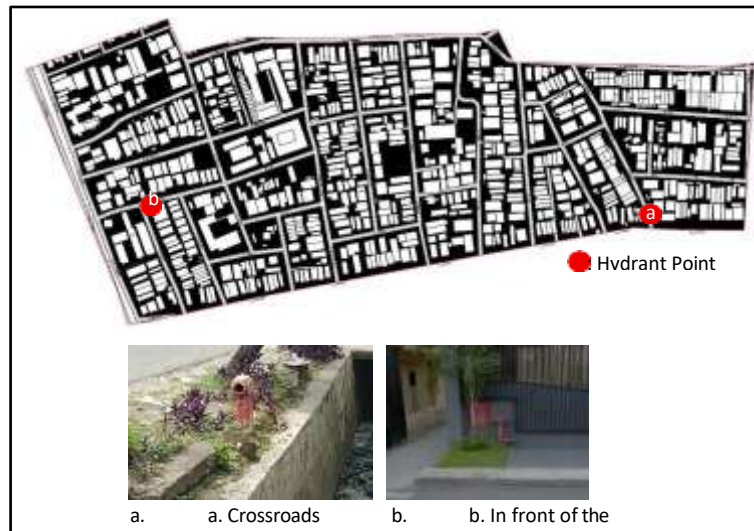
**Figure 13: Hydrant reliability**

Yard hydrants in Sei Rengas Permata Subdistrict are available at several locations within the study area; however, their quantity remains limited. Based on field observations, the physical condition of hydrants varies, with some hydrants still appearing to be in good condition, while others show signs of inadequate maintenance. In addition, not all hydrants have clear information regarding their operational condition or functional status. Overall, the reliability of yard hydrants in Sei Rengas Permata Subdistrict remains uneven due to limitations in quantity, physical condition, and the lack of optimal maintenance practices (Figure 13).

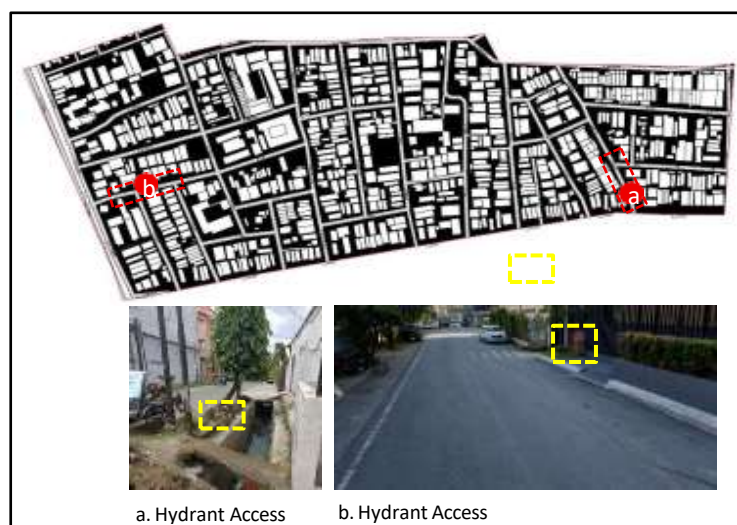
**Figure 14: Hydrant accessibility**

In addition to the physical condition of the hydrants, the location and accessibility of hydrants were also assessed in this study. Yard hydrants in Sei Rengas Permata Subdistrict are generally located along neighborhood access roads with relatively adequate widths, allowing them to be easily identified and accessed from the road network. Most hydrants are positioned in open areas without obstruction from permanent structures; however, their distribution remains limited to only several locations within the study area. As a result, not all parts of the settlement have equal access to the available hydrants. Overall, the accessibility of yard hydrants in Sei Rengas Permata Subdistrict is considered good at the locations where hydrants are available, although their distribution has not yet been evenly spread throughout the study area (Figure 14).

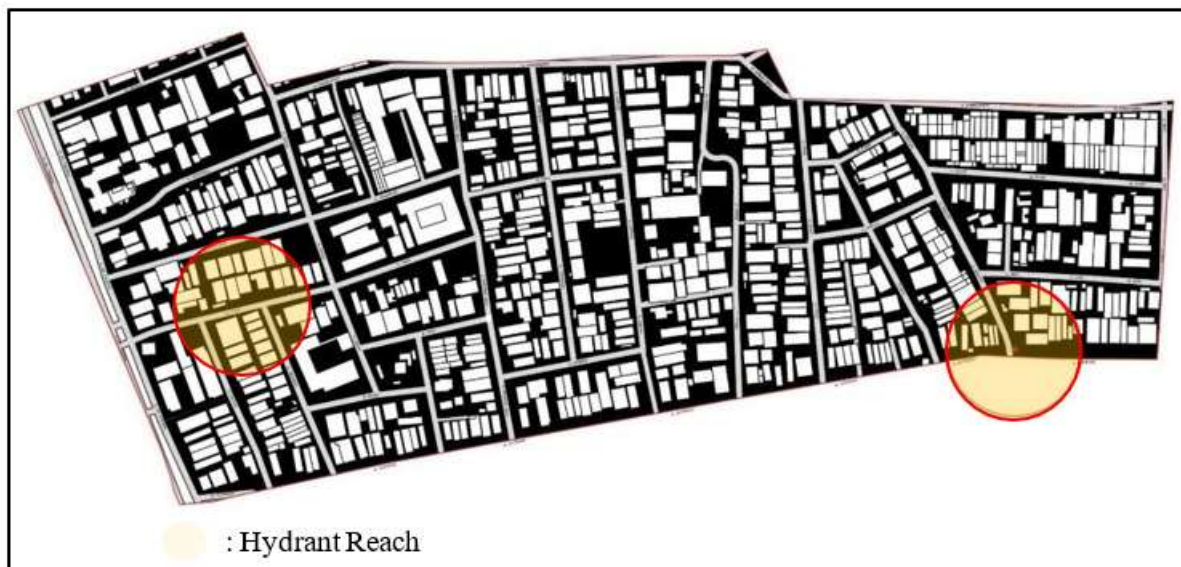
**Figure 15: Hydrant service coverage**

The limited distribution of hydrants also affects their service coverage. Based on field observations, the hydrant service coverage has not yet reached the entire residential area, resulting in several blocks remaining outside the effective service radius. This condition is reflected in the concentration of hydrants at only specific locations, while other parts of the settlement still lack adequate service coverage. Overall, the hydrant service coverage in Sei Rengas Permata Subdistrict is not evenly distributed, indicating that its effectiveness remains limited to the areas surrounding the available hydrant locations (Figure 15).

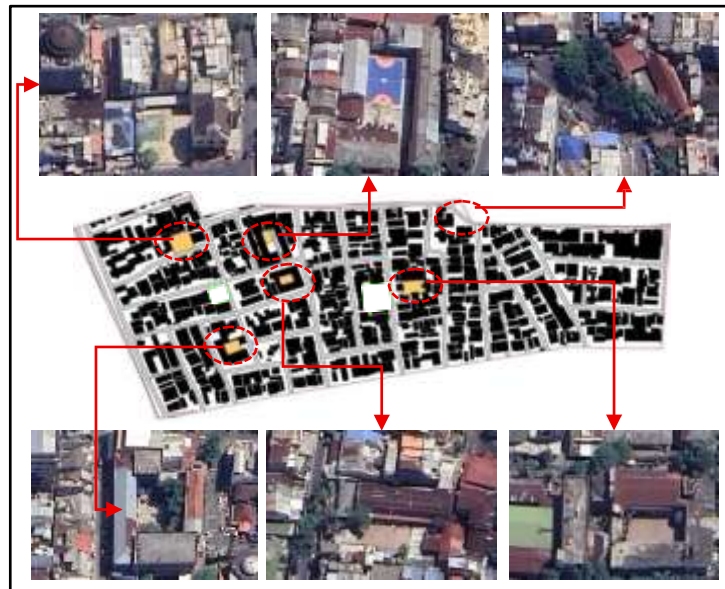
**Figure 16: Types of open spaces**

Sei Rengas Permata Subdistrict has several types of open spaces, including school yards, church courtyards as non-green open spaces, and small parks located around road intersections. These open spaces are distributed across several parts of the area; however, their quantity and size remain relatively limited, and no large-scale open spaces have been identified as dominant features within the residential area (Figure 16).

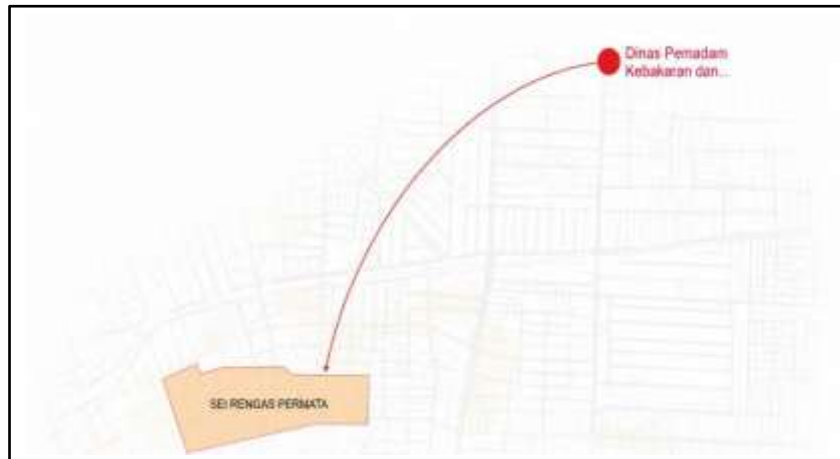
**Figure 17: Service coverage**

Based on the mapping results and interviews, it was identified that Sei Rengas Permata Subdistrict remains within the service coverage area of the nearest Fire and Rescue Unit (UPT) located in Medan Area District. The fire station serves three subdistricts within Medan Area District, including the study area. Therefore, the research location is still included within the operational area of the fire station, allowing fire and rescue services to reach the study area according to the established service coverage boundaries (Figure 17).

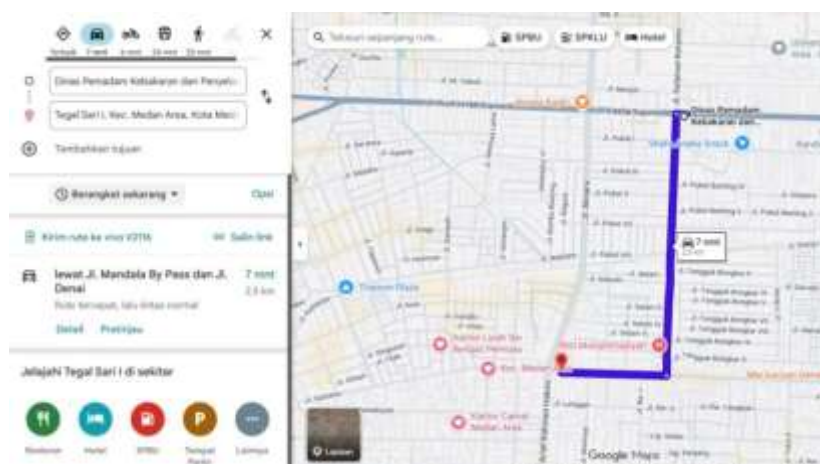
**Figure 18: Response time**

With this service coverage, the capability of the fire station is also determined by the time required to reach the incident location. The response time to Sei Rengas Permata Subdistrict is approximately 10–

11 minutes, based on the primary route connecting the fire station and the study area. Field observations indicate that the road network conditions and the location of the fire station allow personnel to reach the area within a relatively short period. Therefore, the response time meets the requirement of an emergency response duration of less than 15 minutes (Figure 18).

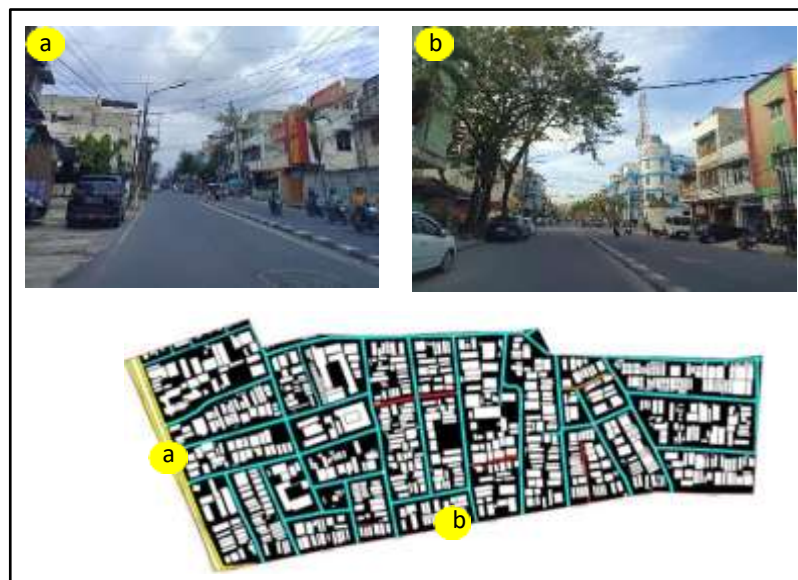
**Figure 19: Access adequacy**

In addition to service coverage, response time, and service radius, the accessibility conditions toward the study area were also assessed in this research. The route to Sei Rengas Permata Subdistrict is predominantly characterized by commercial, service, and residential areas with relatively low to moderate traffic activity. The main roads connecting the fire station to the study area are generally in good condition and accessible for fire vehicles, while access to the inner parts of the settlement is supported by interconnected neighborhood access roads (Figure 19).
