ANALYSIS OF THE PHYSICAL CONDITIONS OF PEDESTRIAN PATHS ON THE CORRIDOR OF SUDIRMAN STREET, TANJUNG PURA AS A CULTURAL HERITAGE AREA

In describing the physical status of the pedestrian path in the Sudirman Street corridor, researchers divided the study location into four segments. The division of features is based on the difference in height from the pedestrian path after researchers made field observations. Segment 1 starts from Rutan Class II Tanjung Pura – Azizi Mosque intersection. Segment 2 begins from the Azizi Mosque – Tomb of Amir Hamzah. Segment 3 starts from the Tomb of Amir Hamzah – Monument Interchange. Segment 4 begins from Monument Interchange– Bridge Interchange.

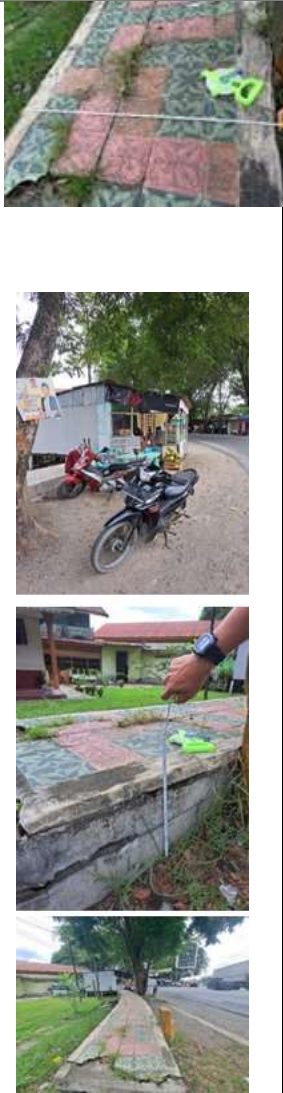
<p>LEFT</p> <p>Accessibility</p> <p>1. Those with physical limitations cannot use pedestrians</p>	<p>Accessibility</p> <p>1. Pedestrians should be accessible to everyone, including those with physical disabilities</p>	<p>Accessibility</p> <p>Not Qualified</p>
		<p>Safety</p> <p>1. There is a difference in height between the pedestrian and the road body</p> <p>2. Safe from acts of vandalism</p> <p>3. No ramps or markings on pedestrians</p> <p>4. Some stalls/stalls stand on the pedestrian path</p>	<p>1. Pedestrians must be separated from the body of the road</p> <p>2. Pedestrians avoid acts of vandalism</p> <p>3. Pedestrian has a ramp or marking</p> <p>4. Pedestrians must be free from any obstructions</p>	<p>Safety</p> <p>Not Qualified</p>
		<p>Comfort</p> <p>1. Pedestrian has a width of 2,30 m</p> <p>2. Pedestrian has several shade trees</p>	<p>Comfort</p> <p>1. Pedestrian has a width of at least 1,5 m</p> <p>2. Has shade vegetation</p>	<p>Comfort</p> <p>Qualified</p>

<p>Aesthetic</p> <p>1. Pedestrian has a width of 2,30 m</p> <p>2. Pedestrian has several shade trees</p>	<p>Aesthetic</p> <p>1. Pedestrian has a patterned covering material and has high absorption</p> <p>2. Has decorative vegetation that can improve aesthetics</p>	<p>Aesthetic</p> <p>Not Qualified</p>
		<p>Ease</p> <p>1. Pedestrians easy to see</p> <p>2. The pedestrian is challenging to reach because the height is 25 cm.</p>	<p>Ease</p> <p>1. Pedestrians should be easy to reach</p> <p>2. Pedestrians should look unobstructed by anything</p>	<p>Ease</p> <p>Not Qualified</p>

No	Photos of Physical Condition	Information Physical Condition	Assessment Criteria	Qualified / Not Qualified
		<p>Interaction</p> <ol style="list-style-type: none"> 1. Pedestrian is used as a place to wait for city transportation 2. Pedestrians are used as a place to sell 	<p>Interaction</p> <p>Pedestrians can attract possibilities for social interaction</p>	<p>Interaction</p> <p>Qualified</p>
2

Table 3 is the result of an assessment of the physical condition of the provisions of [8]. Based on the analysis of the physical condition of the pedestrian paths in segment 1 in Table 2, it can be found that the pedestrian paths do not seem to qualify the assessment criteria. On the left side, the pedestrian paths only qualified the comfort and interaction side, while on the right side, the pedestrian paths only qualified the interaction side. From these results, it can be concluded that the pedestrian paths on the left and right sides of segment one do not qualify the assessment standards, so they need to be an improvement.

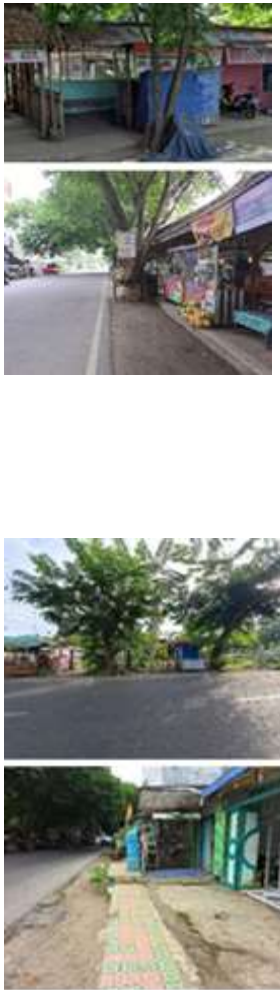
<p>RIGHT</p> <p>Accessibility</p> <ol style="list-style-type: none"> 1. Pedestrians cannot be used by prey who have physical limitations 	<p>Accessibility</p> <ol style="list-style-type: none"> 1. Pedestrians should be accessible to everyone, including those with physical disabilities 	<p>Accessibilit y</p> <p>Not Qualified</p>
		<p>Safety</p> <ol style="list-style-type: none"> 1. There is a difference in height between the pedestrian and the road body 2. Safe from acts of vandalism 3. No ramps or markings on pedestrians 4. Some stalls/stalls stand on the pedestrian path 	<p>Safety</p> <ol style="list-style-type: none"> 1. Pedestrians must be separated from the body of the road 2. Pedestrians avoid acts of vandalism 3. Pedestrian has a ramp or marking 4. Pedestrians must be free from any obstructions 	<p>Safety</p> <p>Not Qualified</p>

<p>Comfort</p> <ol style="list-style-type: none"> 1. Pedestrian has a width of 1,20 m 2. Pedestrian has several shade trees and blocks the pedestrian path 	<p>Comfort</p> <ol style="list-style-type: none"> 1. Pedestrian has a width of at least 1,5 m 2. Has shade vegetation 	<p>Comfort</p> <p>Not Qualified</p>
		<p>Aesthetic</p> <ol style="list-style-type: none"> 1. The covering material (ceramics) is in a broken state. 2. There is no uniqueness in the pedestrian cover material 	<p>Aesthetic</p> <ol style="list-style-type: none"> 1. Pedestrian has a patterned covering material and has high absorption 2. Has decorative vegetation that can improve aesthetics 	<p>Aesthetic</p> <p>Not Qualified</p>
		<p>Ease</p>	<p>Ease</p>	<p>Ease</p>

No	Photos of Physical Condition	Information Physical Condition	Assessment Criteria	Qualified / Not Qualified
		Those with physical limitations cannot use pedestrians	1. Pedestrians should be easy to reach 2. Pedestrians should look unobstructed by anything	Not Qualified
		Interaction 1. Pedestrian is used as a place to wait for city transportation 2. Pedestrians are used as a place to sell	Interaction Pedestrians can attract possibilities for social interaction	Interaction Qualified

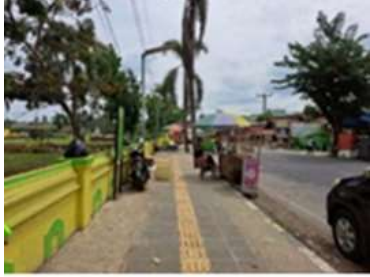
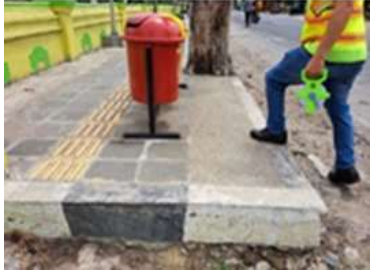
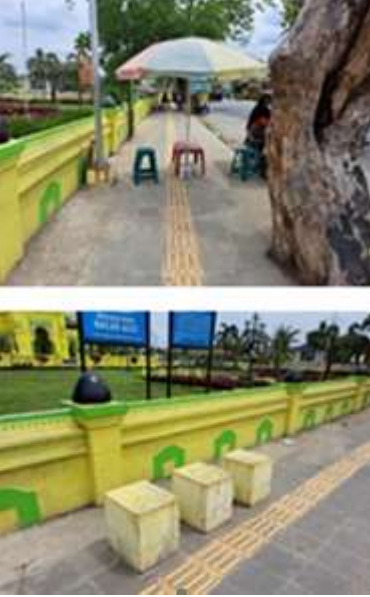
<p>LEFT</p> <p>Accessibility</p> <p>Everyone, including people with disabilities, can use pedestrian</p>	<p>Accessibility</p> <p>Pedestrians should be accessible to everyone, including those with physical disabilities</p>	<p>Accessibility</p> <p>Qualified</p>

<p>Safety</p> <ol style="list-style-type: none"> 1. There is a difference in height between the pedestrian and the road body 2. Safe from acts of vandalism 3. There is a ramp/markings on the pedestrian 4. There is a tent standing on the pedestrian path 5. There are several pieces of pedestrian street furniture standing in the way of the pedestrian path 	<p>Safety</p> <ol style="list-style-type: none"> 1. Pedestrians must be separated from the body of the road 2. Pedestrians avoid acts of vandalism 3. Pedestrian has a ramp or marking 4. Pedestrians must be free from any obstructions 	<p>Safety</p> <p>Qualified, but the pedestrian still has obstacles in the form of tent layout and some street furniture</p>

<p>Comfort</p>	<p>Comfort</p>	<p>Comfort</p> <p>Qualified</p>

No	Photos of Physical Condition	Physical Condition Description	Assessment Criteria	Qualified / Not Qualified
		1. Pedestrian is 2,30 m wide and 2,75 m 2. Pedestrian has several shade trees	1. Pedestrian has a width of at least 1,5 m 2. Has shade vegetation	
		Aesthetic 1. The material covering material is made of concrete material with markings for the disabled path 2. Pedestrian paths look clean and have decorative	Aesthetic 1. Pedestrian has a patterned covering material and has high absorption 2. Has decorative vegetation that can improve aesthetics	Aesthetic Qualified
		Ease 1. Pedestrians easy to see 2. The height of the pedestrian varies, namely 12 cm and 35 cm 3. Some pedestrian paths can be seen blocked by tents and trees	Ease 1. Pedestrians should be easy to reach 2. Pedestrians should look unobstructed by anything	Ease Qualified, but the pedestrian still has obstacles in the form of tents and some furniture

Interaction 1. Pedestrian is used as a place to wait for city transportation	Interaction a) Pedestrians can attract possibilities for social interaction	Interaction Qualified

Table 4 is the result of an assessment of the physical condition of the provisions of [8]. It can be found that, generally, the pedestrian path on the left side has qualified the assessment criteria. Still, it does not qualify the assessment criteria on the right side. The pedestrian path on the left side is a good

pedestrian, but arrangements are still needed regarding the layout of the furniture on the pedestrian path. This is inversely proportional to the assessment results obtained on the right side of the pedestrian path, where the pedestrian path looks integrated with the building. In addition, it can also be seen that the pedestrian material is already in a damaged state, and there is no maintenance on the pedestrian path. The analysis results prove that the pedestrian lanes on the right side need to be improved.

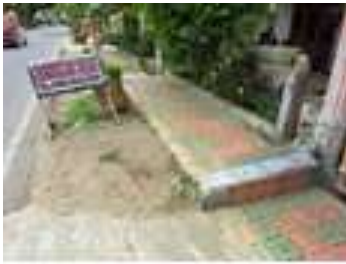
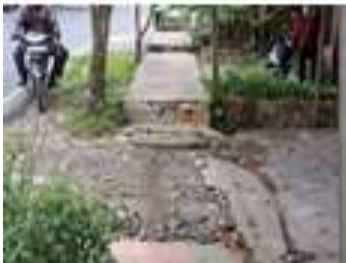
<p><u>RIGHT</u></p> <p>Accessibility</p> <p>Those with physical limitations cannot use pedestrians</p> <p>Safety</p> <ol style="list-style-type: none"> 1. There is a difference in height between the pedestrian and the road body 2. Safe from acts of vandalism 3. No ramps or markings on pedestrians 4. Some stalls/stalls stand on the pedestrian path 5. Some pedestrian paths look as if they are integrated with buildings <p>Comfort</p>	<p>Accessibility</p> <p>Pedestrians must be accessible to everyone, including people with disabilities</p> <p>Safety</p> <ol style="list-style-type: none"> 1. Pedestrians must be separated from the body of the road 2. Pedestrians avoid acts of vandalism 3. Pedestrian has a ramp or marking 4. Pedestrians must be free from any obstructions <p>Comfort</p>	<p>Accessibility</p> <p>Not Qualified</p> <p>Safety</p> <p>Not Qualified</p> <p>Comfort</p>

No	Photos of Physical Condition	Physical Condition Description	Assessment Criteria	Qualified / Not Qualified
		1. Pedestrian has a width of 1,20 m 2. Pedestrian has several shade trees and blocks the pedestrian path	1. Pedestrian has a width of at least 1,5 m 2. Has shade vegetation	Not Qualified
		Aesthetic 1. The covering material (ceramics) is in a broken state. 2. There is no uniqueness in the pedestrian cover material	Aesthetic 1. Pedestrian has a patterned covering material and has high absorption 2. Has decorative vegetation that can improve aesthetics	Aesthetic Not Qualified
		Ease Those with physical limitations cannot use pedestrians	Ease Pedestrians should be easy to reach	Ease Not Qualified
		Interaction Pedestrians look integrated with the building, so there are no activities that can be done	Interaction Pedestrians can attract possibilities for social interaction	Interaction Not Qualified

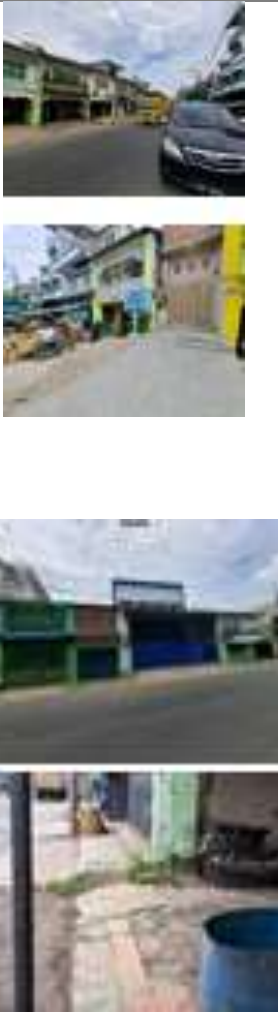
<p>disabilities cannot use pedestrian</p> <p>Safety</p> <ol style="list-style-type: none"> 1. There is no height difference between the pedestrian path and the road body 2. Pedestrian paths look unsafe 3. No ramps or markings on pedestrians 4. There is a shophouse that stands on the pedestrian path <p>Comfort</p> <ol style="list-style-type: none"> 1. The width of the pedestrian varies, namely 1.10 m and 0.90 m 2. The pedestrian does not have shade trees <p>Aesthetic</p> <ol style="list-style-type: none"> 1. The covering material (ceramics) is in a broken state. 2. There is no uniqueness in the pedestrian cover material 	<p>Safety</p> <ol style="list-style-type: none"> 1. Pedestrians must be separated from the body of the road 2. Pedestrians avoid acts of vandalism 3. Pedestrian has a ramp or marking 4. Pedestrians must be free from any obstructions <p>Comfort</p> <ol style="list-style-type: none"> 1. Pedestrian has a width of at least 1,5 m 2. Has shade vegetation <p>Aesthetic</p> <ol style="list-style-type: none"> 1. Pedestrian has a patterned covering material and has high absorption 2. Has decorative vegetation that can improve aesthetics 	<p></p> <p>Safety</p> <p>Not Qualified</p> <p>Comfort</p> <p>Not Qualified</p> <p>Aesthetic</p> <p>Not Qualified</p>

No	Photos of Physical Condition	Physical Condition Description	Assessment Criteria	Qualified / Not Qualified
		<p>Ease</p> <p>Pedestrians and those with physical disabilities cannot use the pedestrian</p>	<p>Ease</p> <p>1. Pedestrians should be easy to reach 2. Pedestrians should look unobstructed by anything</p>	<p>Ease</p> <p>Not Qualified</p>
		<p>Interaction</p> <p>1. Pedestrians are used as a place to sell 2. Pedestrian used as a parking lot</p>	<p>Interaction</p> <p>Pedestrians can attract possibilities for social interaction</p>	<p>Interaction</p> <p>Qualified</p>

Table 5 is the result of an assessment of the physical condition of the provisions of [8]. Based on it, it can be found that the pedestrian path in segment three does not qualify for the assessment criteria. Many pedestrian paths look damaged and are integrated with the shophouse building. However, when viewed in terms of interaction, the pedestrian path is used as a parking lot and a place to sell so that pedestrians can no longer pass through the pedestrian path. The pedestrian path in segment three needs improvement.

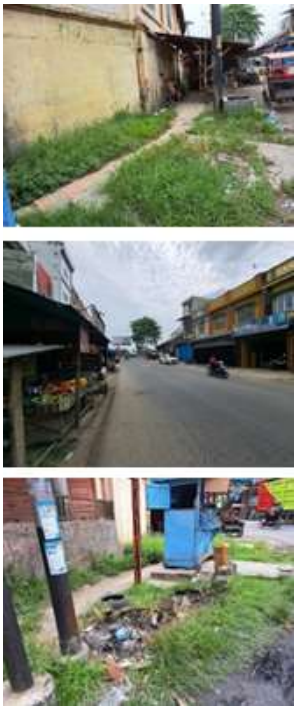
<p><u>LEFT</u></p> <p>Accessibility</p> <p>Pedestrians and those with physical disabilities cannot use a pedestrian</p>	<p>Accessibility</p> <p>Pedestrians should be accessible to everyone, including those with physical disabilities</p>	<p>Accessibility</p> <p>Not Qualified</p>
		<p>Safety</p> <ol style="list-style-type: none"> 1. There is no height difference between the pedestrian path and the road body 2. Pedestrian paths look unsafe 3. No ramps or markings on pedestrians 4. There are shophouses/stalls/stalls that stand on the pedestrian path 	<p>Safety</p> <ol style="list-style-type: none"> 1. Pedestrians must be separated from the body of the road 2. Pedestrians avoid acts of vandalism 3. Pedestrian has a ramp or marking 4. Pedestrians must be free from any obstructions 	<p>Safety</p> <p>Not Qualified</p>

<p>Comfort</p> <ol style="list-style-type: none"> 1. Pedestrian width 0,80 m 2. The pedestrian does not have shade trees 	<p>Comfort</p> <ol style="list-style-type: none"> 1. Pedestrian has a width of at least 1,5 m 2. Has shade vegetation 	<p>Comfort</p> <p>Not Qualified</p>
		<p>Aesthetic</p> <ol style="list-style-type: none"> 1. The covering material (ceramics) is in a broken state. 	<p>Aesthetic</p> <ol style="list-style-type: none"> 1. Pedestrian has a patterned covering material and has high absorption 	<p>Aesthetic</p> <p>Not Qualified</p>

2. There is no unique character in the pedestrian	2. Has decorative vegetation that can improve aesthetics	
		Ease 1. Pedestrians are almost invisible because they blend into the building 2. A pedestrian looks unusable because the building blocks it	Ease 1. Pedestrians should be easy to reach 2. Pedestrians should look unobstructed by anything	Ease Not Qualified
		Interaction 1. Pedestrians are used as a place to sell 2. Pedestrian used as a parking lot	Interaction Pedestrians can attract possibilities for social interaction	Interaction Qualified

Table 6 is the result of an assessment of the physical condition of the provisions of [8]. Based on it, it can be found that the pedestrian path in segment four does not qualify for the assessment criteria. Many pedestrian paths are already in a state of disrepair and endanger the safety of users, such as many sewer openings. This analysis proves that the revitalization of pedestrian paths in segment 4 needs improvement.
