## DEVELOPMENT OF FLOOD MITIGATION STRATEGIES IN FLOOD-PRONE SETTLEMENTS OF BERINGIN VILLAGE, MEDAN CITY

**KEYWORDS:** Flood Mitigation, Flood-Prone Settlements, Risk-Based Spatial Planning, Green Infrastructure, Drainage Enhancement.

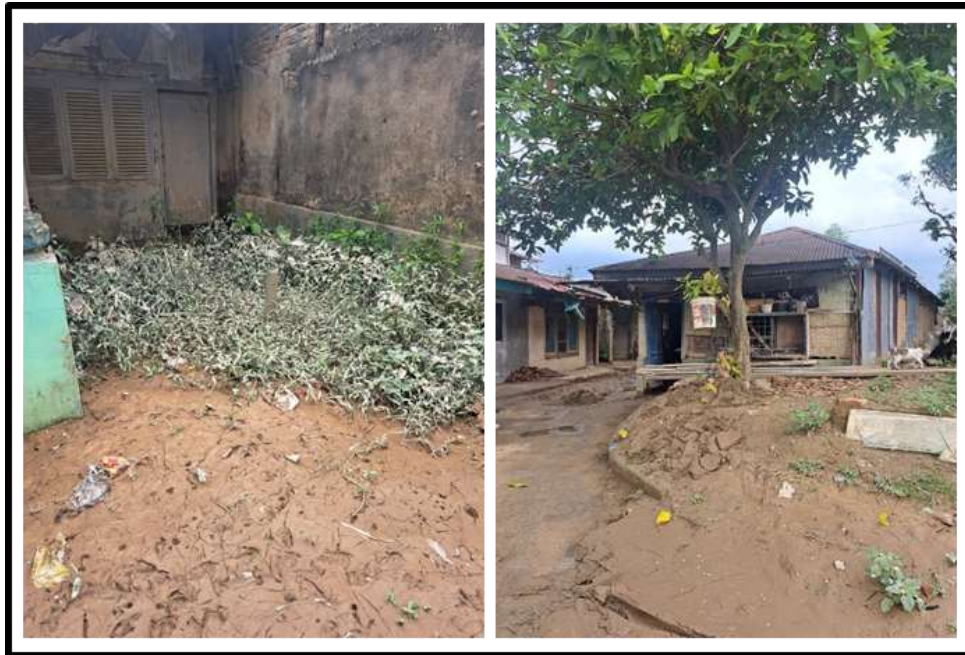
**Figure 2: Flood-Affected Wall Condition**

Wall structures are the building components most frequently exposed to direct contact with floodwater. Field observations revealed that the lower sections of walls are the most vulnerable areas, often experiencing water seepage, moisture accumulation, plaster deterioration, and material degradation due to recurrent flooding. (Figure 2)

This finding is consistent with [19], who reported that building materials located closest to floodwater are subject to higher rates of deterioration compared to other parts of a building.

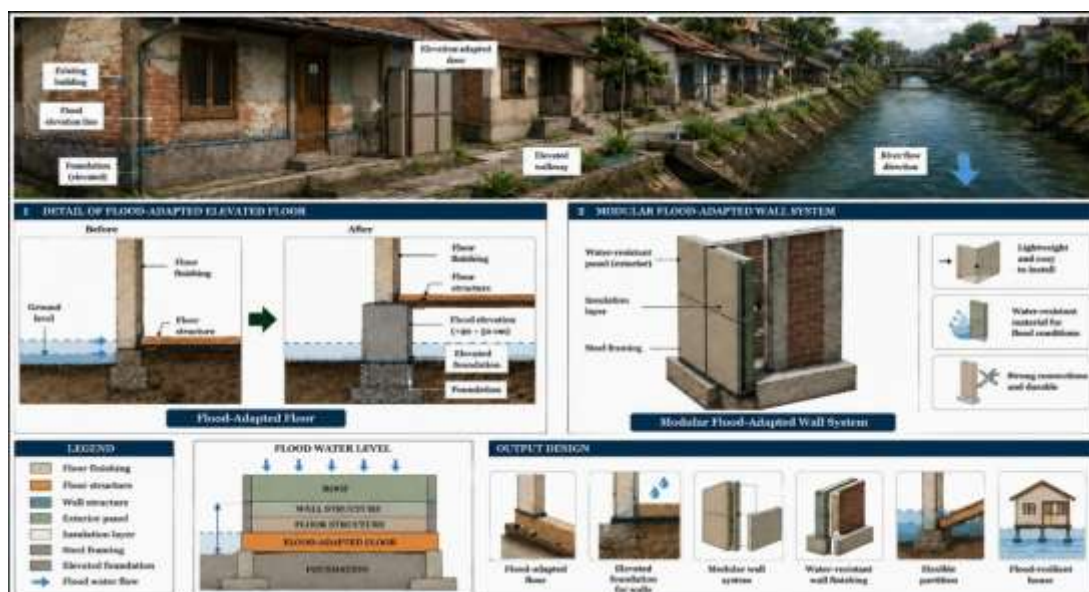
Figure 3: Wall Structure Design Strategy

To address these conditions, several mitigation strategies are recommended. The application of a higher raised plinth can reduce direct contact between floodwater and building walls [20]. In addition, the use of modular wall systems or double-layer wall construction allows flood-damaged sections to be repaired or replaced without compromising the overall structural integrity of the building [21]. These strategies are expected to improve the durability of building envelopes and reduce maintenance costs associated with recurrent flooding. (Figure 3)

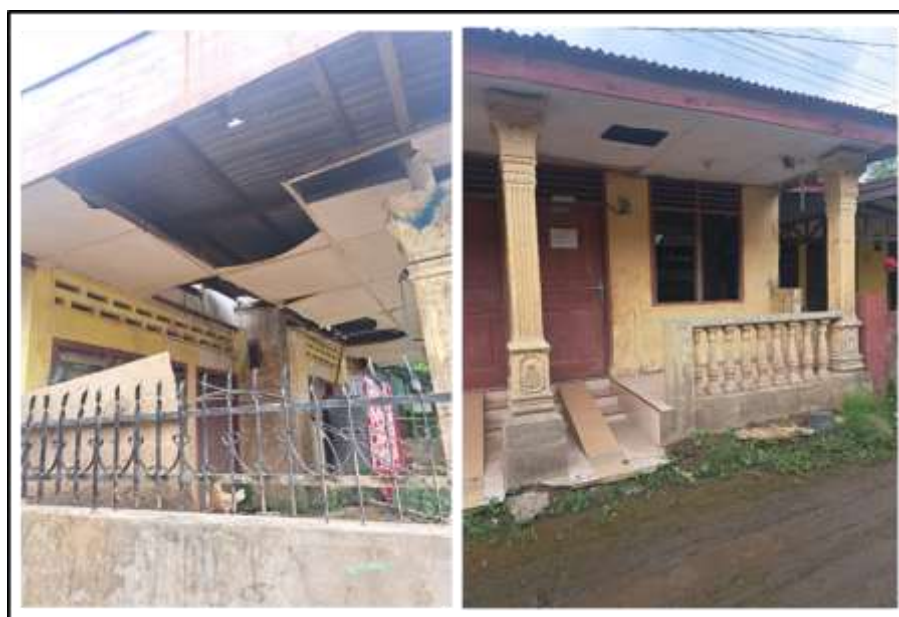
Figure 4: Existing Roof Condition

The findings indicate that roof structures have the potential to function as temporary safe spaces during high flood events. In several locations situated near riverbanks, roofs become the last usable area for residents when the ground floor is completely inundated. This condition demonstrates that roofs serve not only as protective building elements but also as integral components of flood mitigation and evacuation systems. (Figure 4)

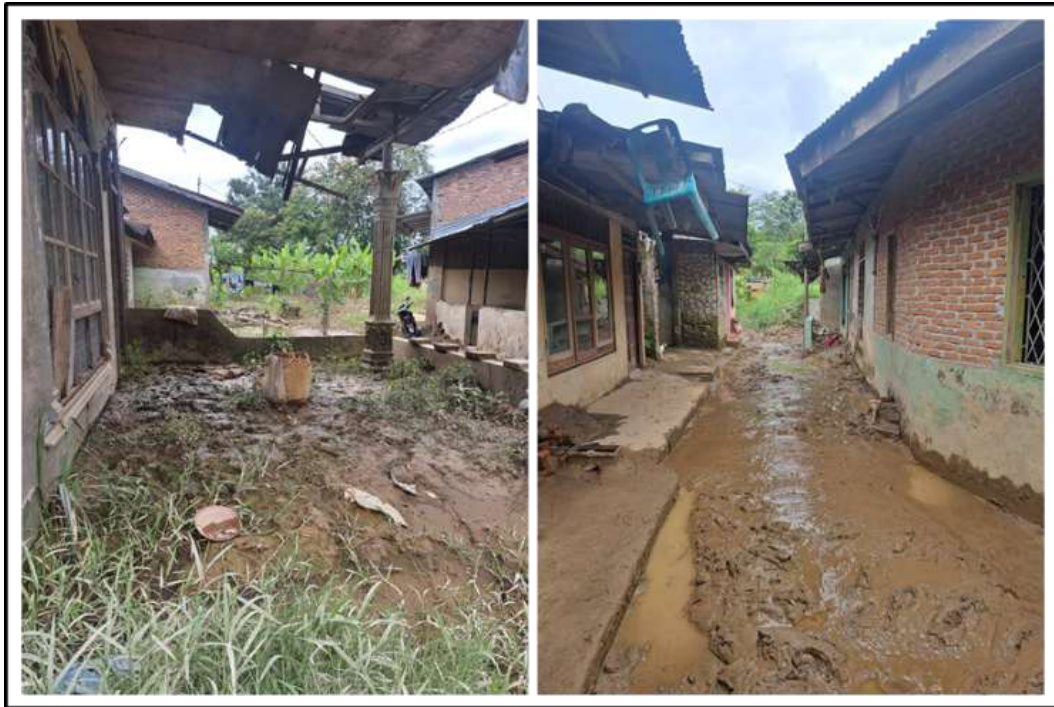
**Figure 6: Existing Floor Condition**

Floor Floor elevation is one of the primary building elements for reducing the direct impacts of flooding on residential spaces. Field observations revealed that most houses in Beringin Village are situated at relatively low elevations, making them highly susceptible to inundation during periods of increased river discharge and heavy rainfall. These conditions disrupt residents' daily activities and increase the risk of damage to the main living areas of buildings. (Figure 6)

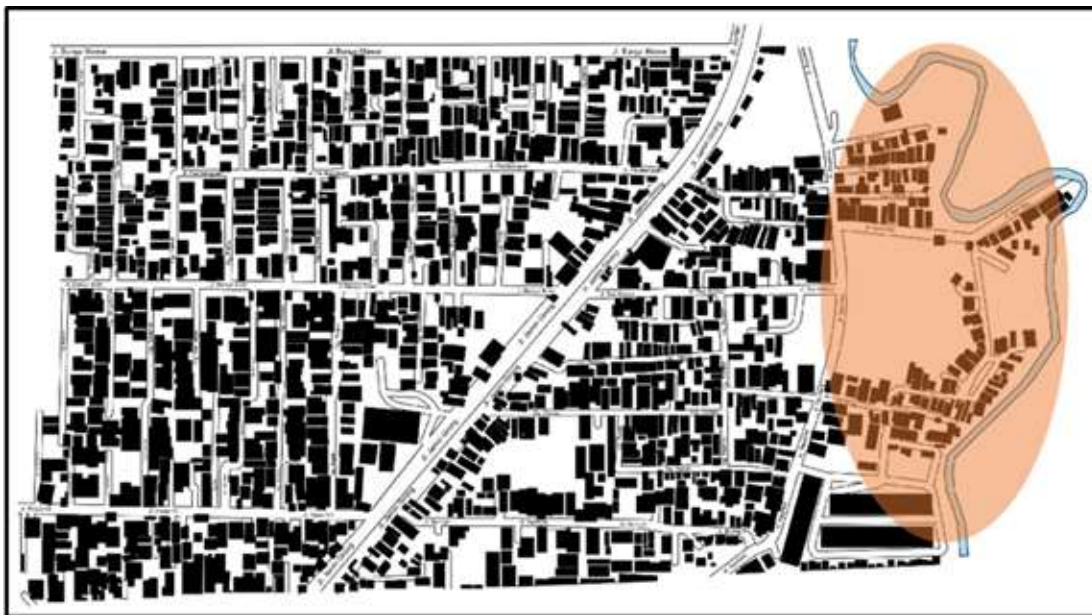
**Figure 8: Building Density in the Riverbank Area**

Field observations revealed that several residential areas in Beringin Village have developed organically, resulting in relatively narrow spacing between buildings, particularly in areas adjacent to the riverbanks. High building density reduces the availability of open spaces that function as rainwater infiltration areas, thereby increasing surface runoff and making the area more susceptible to flooding. (Figure 8)

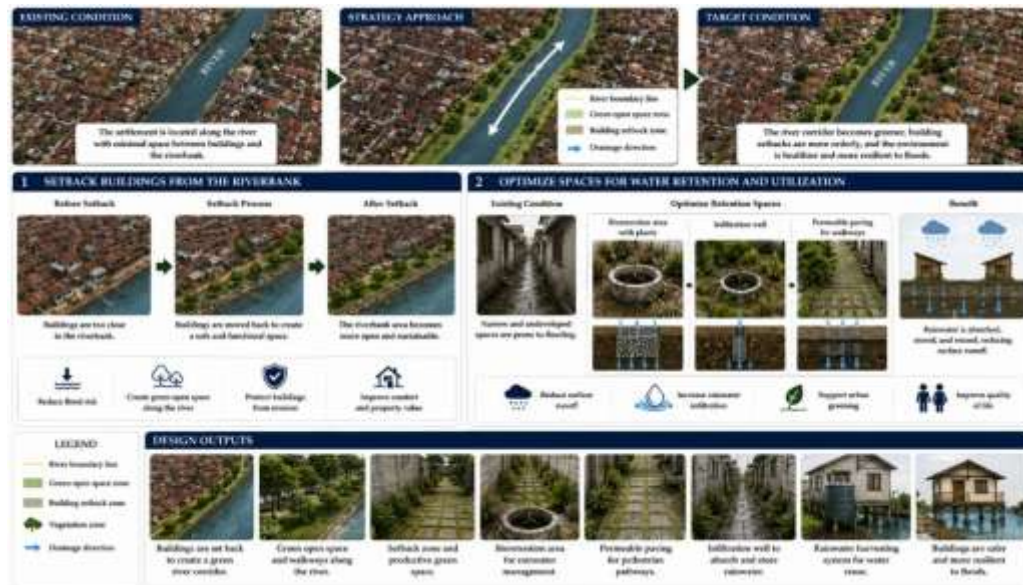
Figure 9: Building Density Design Strategy

To address these conditions, the recommended mitigation strategies include the reorganization of building masses in riverbank areas that do not comply with river setback regulations in order to restore the protective functions of river buffer zones [30]. In addition, the optimization of spaces between buildings as micro-infiltration areas through the implementation of infiltration wells and biopore infiltration holes is essential to enhance rainwater absorption and reduce surface runoff [31][32]. These interventions are expected to improve local hydrological performance and reduce flood vulnerability in densely built residential areas. (Figure 9)

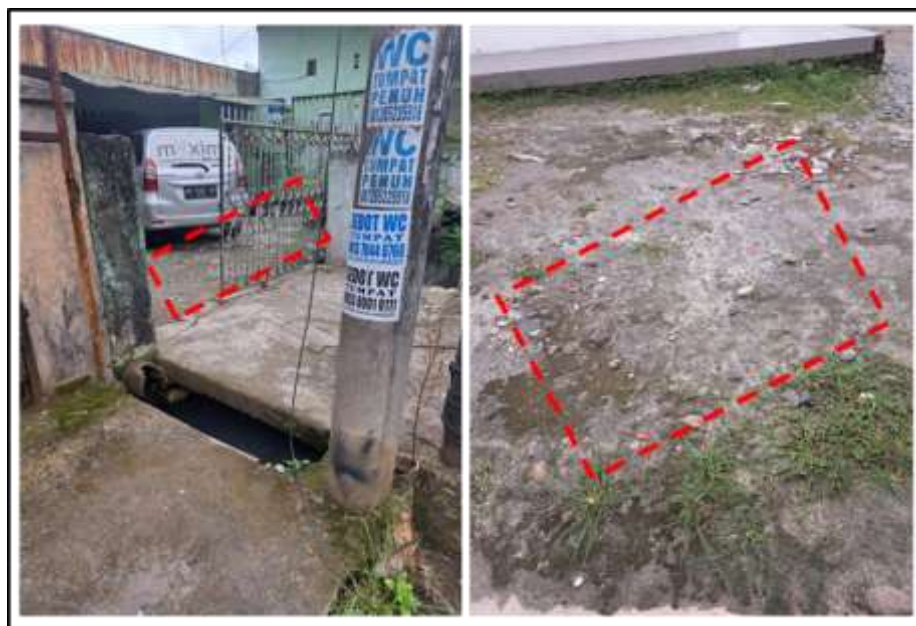
Figure 10: Dominance of Impervious Surfaces in the Settlement Area

The findings indicate that land use in Beringin Village is predominantly characterized by built-up areas with a high proportion of impervious surfaces. This condition causes a significant portion of rainfall to be directly converted into surface runoff, thereby increasing the burden on the drainage system and elevating the potential for flooding and waterlogging. (Figure 10)

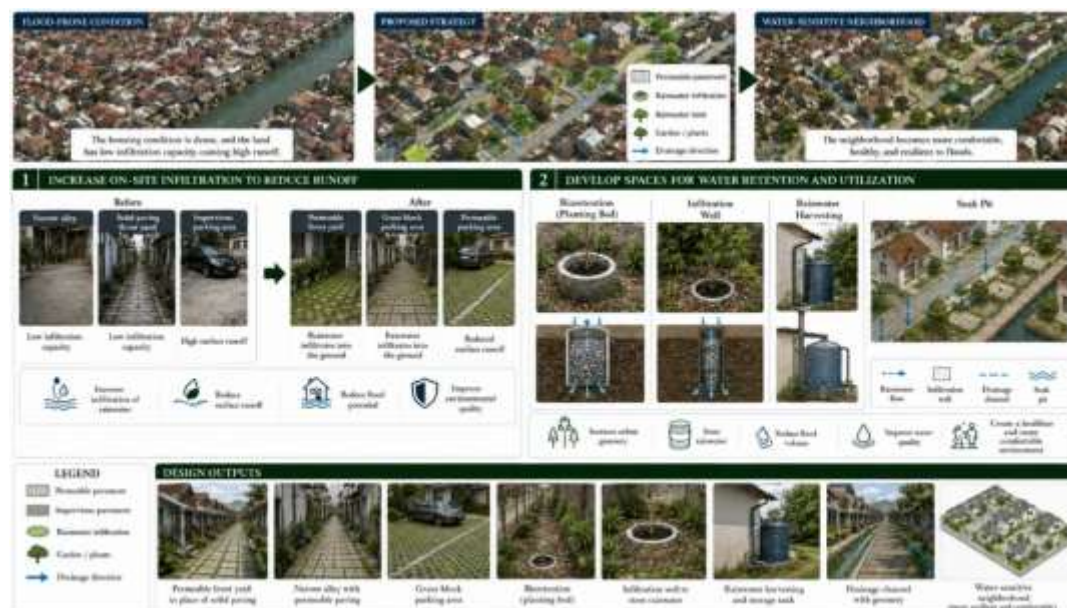
Figure 11: Land Use Design Strategy

To address these conditions, the recommended mitigation strategies focus on improving surface permeability and enhancing local water retention capacity. This can be achieved through the use of permeable materials such as grass blocks, porous paving, and permeable pavements in residential yards and pedestrian pathways to facilitate rainwater infiltration and reduce surface runoff [35][34]. In addition, the development of integrated micro-infiltration systems, including infiltration wells, biopore infiltration holes, and rainwater harvesting systems, is essential to improve rainwater absorption and increase local water storage capacity [31]. These measures are expected to reduce runoff generation and mitigate the risk of urban flooding in the study area. (Figure 11)

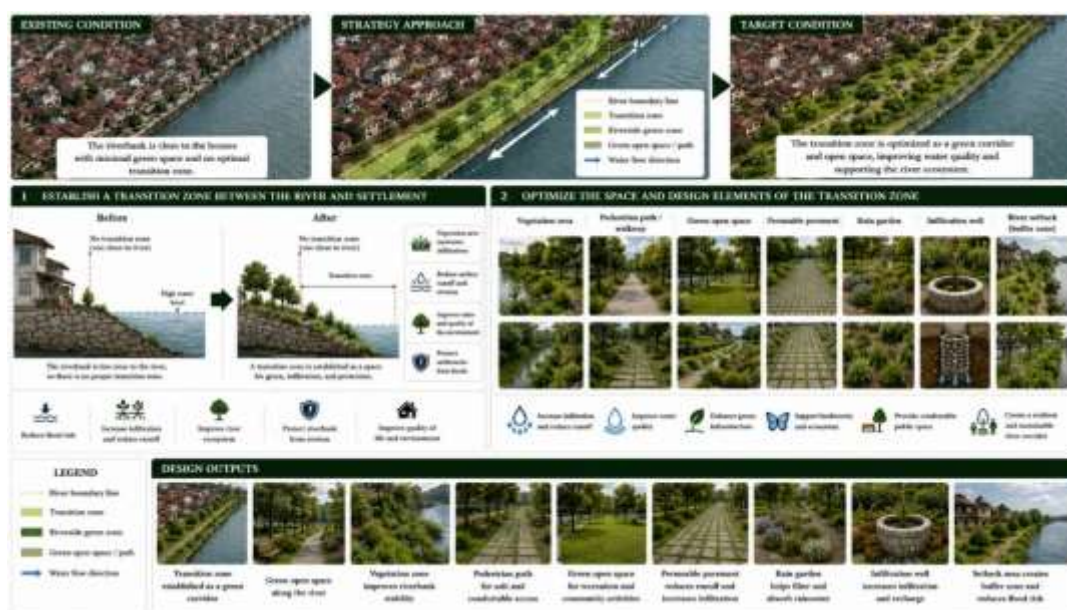
Figure 13: Residential Distance to River Design Strategy

To address these conditions, the recommended mitigation strategy focuses on strengthening the river setback buffer zone as an area for water retention and flow attenuation through the enhancement of vegetation cover and the provision of green open spaces, thereby improving its ecological and hydrological functions [36]. This approach is expected to reduce flood exposure and restore the protective role of riparian areas. (Figure 13)

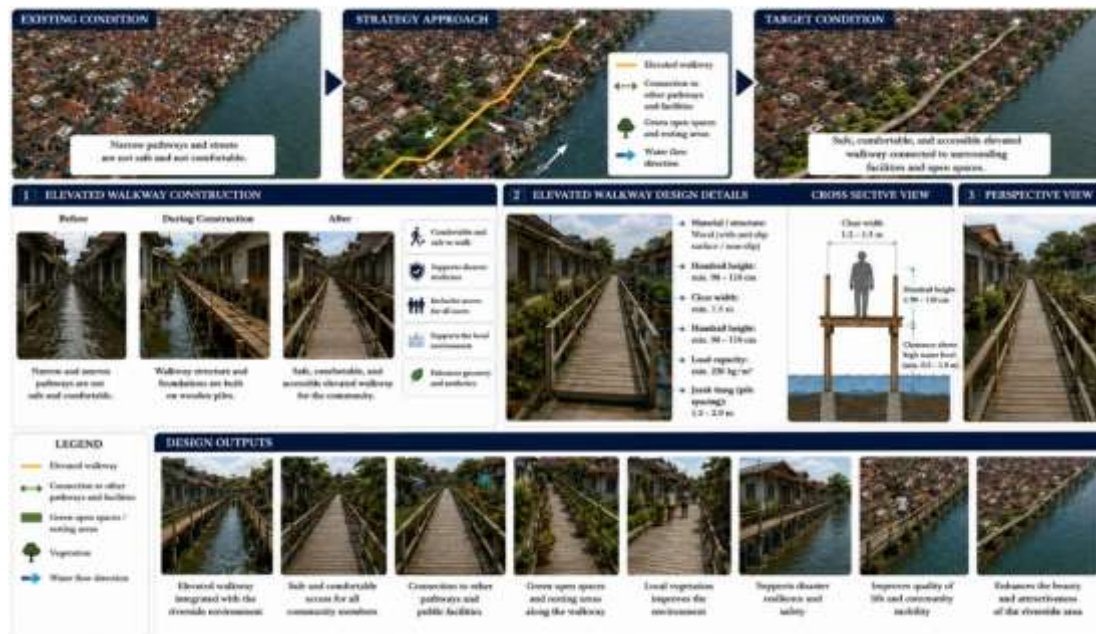
Figure 15: Circulation System and Neighborhood Road Design Strategy

To address these challenges, the recommended mitigation strategy includes the construction of elevated walkways along residential corridors that are frequently inundated, in order to maintain connectivity and ensure continuous accessibility during flood events [39]. This approach is expected to support evacuation processes and improve overall mobility and safety during flooding situations. (Figure 15)

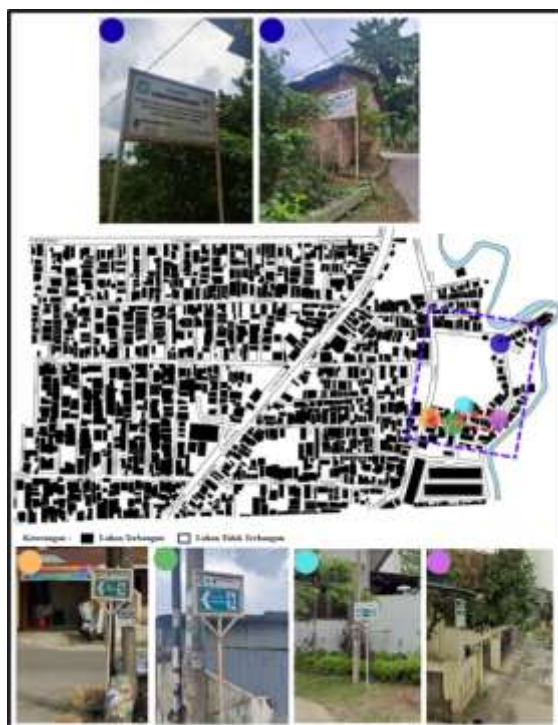
**Figure 16: Evacuation Route Signage and Flood Hazard Warning Signs in the Settlement Area**

Field observations indicate that evacuation signage and designated evacuation routes in Beringin Village remain limited and are unevenly distributed across the settlement. This condition creates difficulties in spatial orientation during flood events, particularly under low-visibility conditions such as nighttime or adverse weather. Consequently, residents may face challenges in identifying and following safe evacuation paths when rapid movement to safer areas is required. (Figure 16)

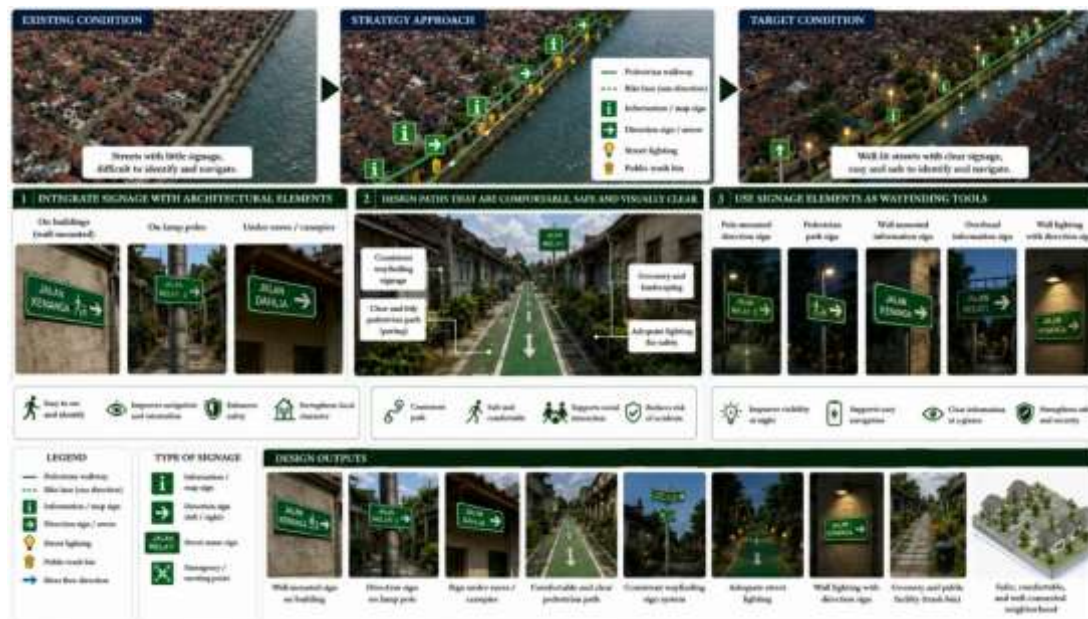
Figure 17: Evacuation Signage and Route System Design Strategy

To address these challenges, several mitigation strategies are proposed. Evacuation signage should be integrated with architectural elements such as walls, utility poles, and building façades to improve visibility and ensure consistent placement of emergency information throughout the settlement [41]. In addition, evacuation routes should be designed to be easily recognizable both visually and spatially through clear directional cues and strong route connectivity, ensuring intuitive navigation toward safe areas during emergency situations [42][43]. Furthermore, lighting elements can be utilized as directional markers to enhance the visibility of evacuation routes under low-light conditions, thereby improving safety and response effectiveness during flood events [44][45]. **(Figure 17)**

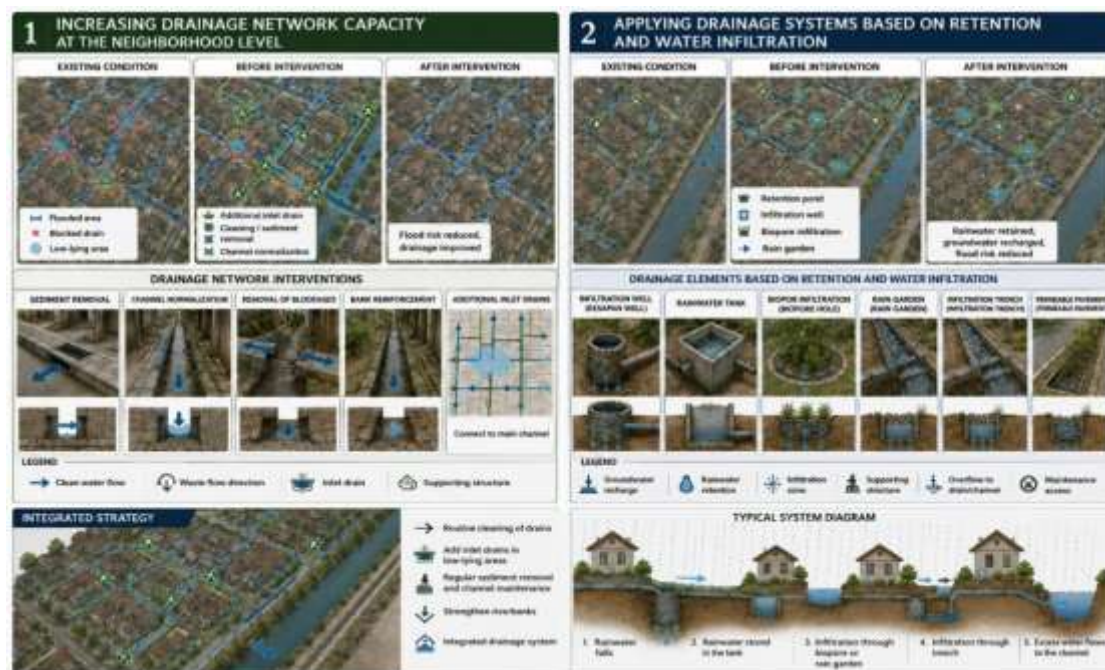
Figure 19: Environmental Drainage System Design Strategy

To address these issues, the proposed mitigation strategies focus on strengthening an integrated micro-drainage network by improving connectivity between channels and resolving bottleneck sections within the system [46]. Furthermore, a detention- and retention-based drainage approach is recommended, which aims to slow surface runoff through the implementation of infiltration wells, micro-retention basins, and other infiltration facilities to enhance local water absorption capacity [48]. These strategies are expected to improve drainage performance, reduce surface runoff accumulation, and minimize localized flooding within the settlement. **(Figure 19)**

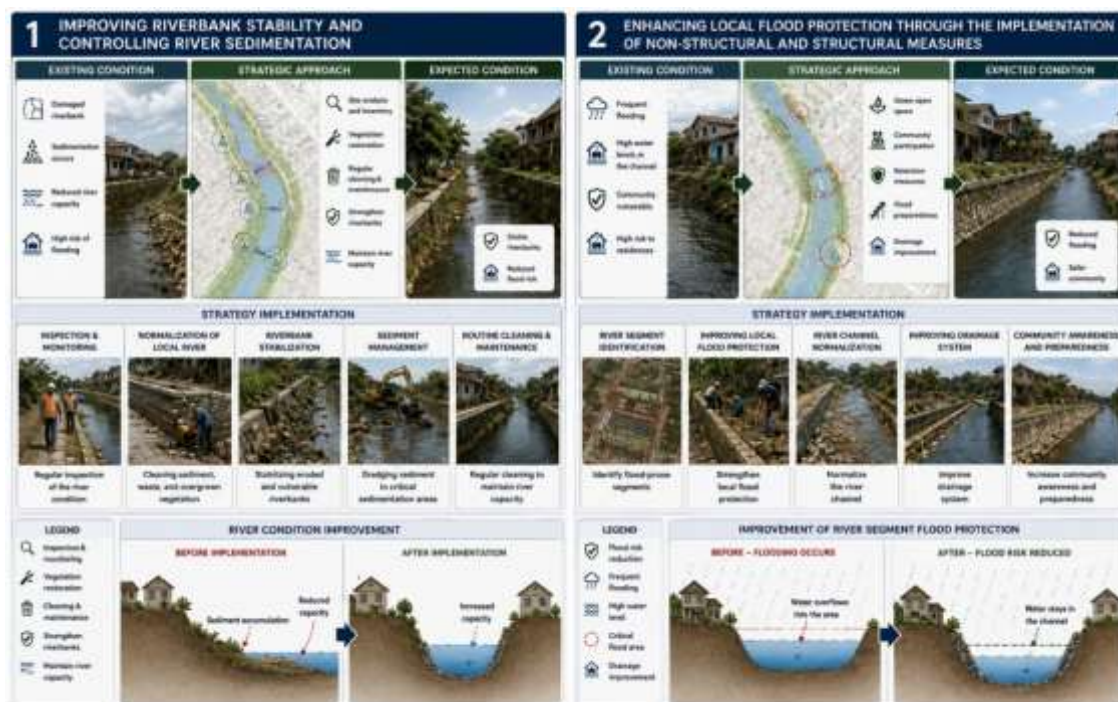
Figure 21: River Embankment Design Strategy

To address these challenges, several mitigation strategies are recommended. Routine maintenance of embankments and sedimentation control should be implemented through periodic inspections, channel cleaning, and dredging of river sections experiencing sediment accumulation in order to maintain adequate river conveyance capacity [29]. In addition, local embankment protection should be strengthened through the construction or reinforcement of low embankments at critical locations that frequently serve as pathways for floodwater intrusion into residential areas [17][49]. These measures are expected to enhance the effectiveness of river protection systems, reduce flood exposure, and improve the resilience of flood-prone settlements. (Figure 21)
